FIRE SAFETY FOLLOW UP INSPECTION

Factory Name	MEGHNA KNIT COMPOSITE LIMITED		Accord ID	9508
Address	SRIIPUR ROAD, GILARCHALA, SRIIPUR			
Inspection Date	08/04/2014		Report Received Date	
Date of 1st Follow-up	04/09/2014	Date of 2nd Follow-up	07/12/2015	
Date of 3rd Follow-up	16/03/2016	Date of 4th Follow-up	04/09/2016	
Date of 5th Follow-up	23/11/2016	Date of 6th Follow-up	07/02/2017	
Date of 7th Follow-up	30/04/2017	Date of 8th Follow-up	10/08/2017	
Date of 9th Follow-up	02/04/2018	Date of 10th Follow-up	01/08/2018	
Date of 11th Follow-up		Date of 12th Follow-up		
Date of 13th Follow-up		Date of 14th Follow-up		
Inspected by	Johana Sharmin

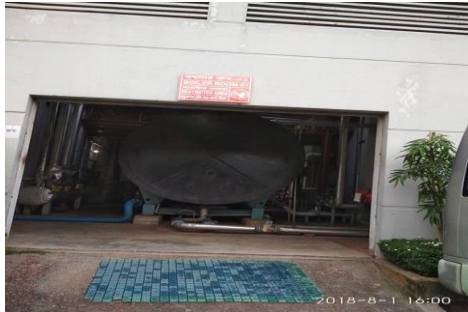
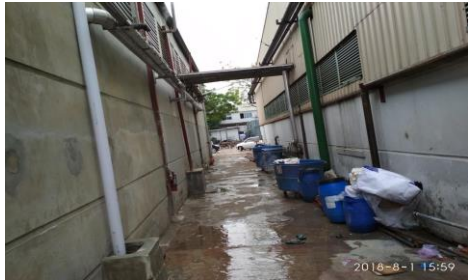
1	The boiler building has unprotected openings less than 10 ft from the adjacent Dyeing section.	Separate the boiler building exterior walls with minimum 2hr fire-rated construction. Seal and/or protected all openings to maintain the required fire separations.	Within 3 months	<p>On 16/03/2016: Corrected.</p> <p>On 04/09/2016: Corrected as per site observation.</p> <p>On 23.11.2016: Corrected as per site condition.</p> <p>On 7th February 2017 As action plan of the factory: Corrected as per previous follow-up inspection.</p> <p>On 30/04/2017: Corrected</p> <p>On 10.08.2017: Corrected as per site observation.</p> <p>On 02/02/2018: Corrected as per site observation.</p> <p>On 01/08/2018: Corrected.</p>	16/03/2016	Done	Corrected	
---	--	---	-----------------	--	------------	------	-----------	--

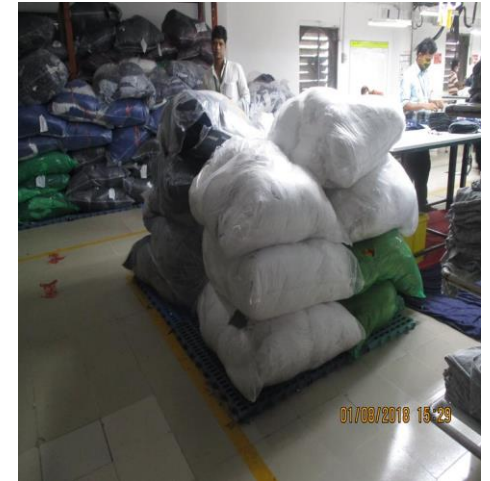
2 Areas used for combustible storage are not separated by fire-rated construction. Locations include Levels Ground, 1, 2, 3, 4, and 5

On 16/03/2016: No action has been taken yet. It has found same as it was before.
 Final CAP Timeline: Expired.
 Committed Timeline: Within 30th March 2016.
 On 04/09/2016: No action has been taken yet.
 On 23.11.2016: It was found same as 4th follow-up inspection during 5th follow-up inspection.
 On 7th February 2017 As action plan of the factory: In Progress. It has found same as it was before follow-up inspection.
 On 30/04/2017: In progress.
 On 10.08.2017: Corrected as per site observation. Storage was found in compliant way during inspection.
 On 02/02/2018: Corrected as per site observation.
 On 01/08/2018: Corrected.

Provide dedicated storage rooms separated by minimum 1-hr fire-rated construction. Where separate storage rooms are not feasible, provide defined storage areas and limit the storage arrangement as follows:-
 Maximum height of 2.4m and maximum area of 23m² - If sprinkler protected: maximum height of 3.66m and maximum area of 93m² Separate areas of unenclosed combustible storage by a minimum clear distance of 3m.

We're in process to separate the floor's combustible storage in all levels

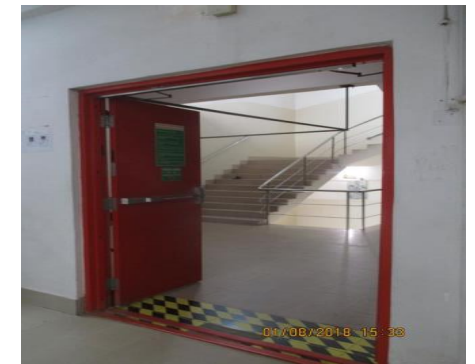
3 The north exit stairs are not separated from each floor by fire-rated construction. The south exit stairs are separated by red metal doors for which the factory does not currently have certification demonstrating

On 23.11.2016: In progress. All doors are in-house and installation is almost completed, only 1 door left to be installed. Interfacing with FACP is not completed.
 On 7th February 2017 As action plan of the factory: Corrected. Corrected. Factory has installed the fire door.
 On 30/04/2017: Corrected
 On 10.08.2017: Corrected as per site observation.
 On 02/02/2018: Corrected as per site observation. Note- Office room (Two room) has not been separated with Fire rated construction. Interfacing work is pending.
 On 01/08/2018: Corrected. Note: Factory shall ensure that fire doors shall not be opened with external objects.

Provide minimum 1.5-hr fire rated doors and seal all unprotected openings to separate the exit stairs from work areas and other building spaces on all floor levels. Ensure that the fire doors are self-closing and positive latching and that they are provided with fire exit (panic) hardware where serving production floors. If fire doors are required to

We've replaced the doors by UL certified fire rated doors. We're in process to install self-closing and positive latching to the fire doors.

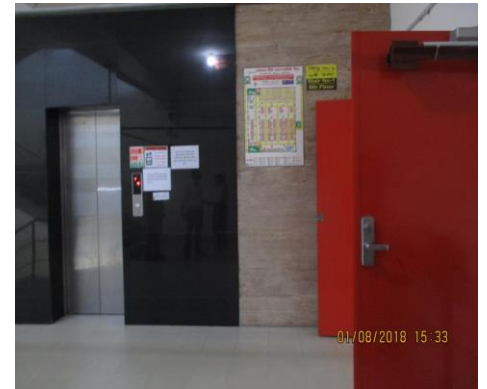
5	Elevator shafts (both current and future) have unprotected openings to adjacent stairwells.	Separate the elevator shaft ways and machine rooms with minimum 2-hr fire-rated construction. Seal and/or protected all openings to maintain the required fire separations.	Within 3 months	On 04/09/2016: Work in progress. Fire door has been installed. But it did not function properly during follow-up inspection. On 23.11.2016: Corrected as per site observation. Elevator shaft is outside of production floor. On 7th February 2017 As action plan of the factory: Corrected as per previous follow-up inspection. On 30/04/2017: Corrected On 10.08.2017: Corrected as per site observation. On 02/02/2018: Corrected as per site observation. On 01/08/2018: Corrected.	'30/06/2016	We're on process to protect the elevator shafts openings to adjacent stairwells	Corrected	
---	---	---	-----------------	--	-------------	---	-----------	--

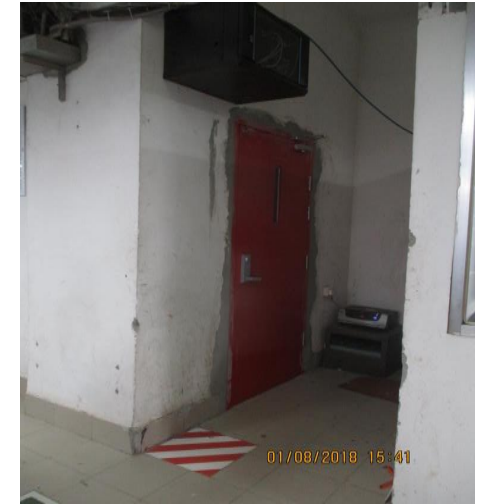
6	Utility shafts have unprotected openings to factory floors.	Separate the utility shafts with minimum 2-hr fire-rated construction. Seal and/or protected all openings to maintain the required fire separations.	Within 3 months	<p>On 16/03/2016: Not corrected. Factory has separated the utility shaft by non rated materials. Final CAP Timeline: Expired. Committed Timeline: Within 30th March 2016.</p> <p>On 04/09/2016: Not corrected. Work in progress.</p> <p>On 23.11.2016: It was found same as 4th follow-up inspection during 5th follow-up inspection.</p> <p>On 7th February 2017 As action plan of the factory: In Progress. It has found same as it was before follow-up inspection.</p> <p>On 30/04/2017: It was found same as it was before.</p> <p>On 10.08.2017: LC for fire doors have been opened.</p> <p>On 02/02/2018: Fire door has been arrived. Installation shall be started soon.</p> <p>On 01/08/2018: Corrected.</p>	'30/09/2016	We have separated the utility shaft with Fire rated door.	Corrected

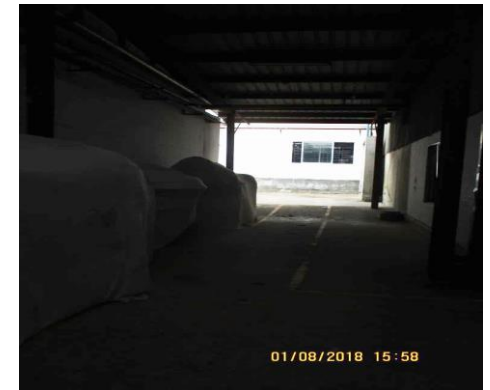
7	Unprotected openings are located between Level 1 knitting and Ground floor Dyeing section including a chute for material transfer and vents.	Seal all penetrations and openings in floor/ceiling assemblies to maintain the fire separation. Remove chute.	Within 3 months	<p>On 16/03/2016: No action has been taken yet. It has found same as it was before. Final CAP Timeline: Expired. Committed Timeline: Within 30th March 2016.</p> <p>On 04/09/2016: Corrected as per site observation.</p> <p>On 23.11.2016: Corrected</p> <p>On 7th February 2017 As action plan of the factory: Corrected as per previous follow-up inspection.</p> <p>On 30/04/2017: Corrected</p> <p>On 10.08.2017: Corrected as per site observation.</p> <p>On 02/02/2018: Corrected.</p> <p>On 01/08/2018: Corrected.</p>	'30/09/2016	We've sealed the unprotected openings of level 1 Knitting and ground floor dyeing section	Corrected	
---	--	---	-----------------	---	-------------	---	-----------	--

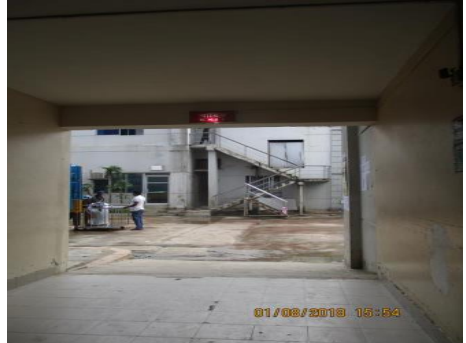
9	Collapsible gates/ sliding doors are provided at building exits, exit stairs, along egress routes, and means of exit discharge.	Replace all gates / sliding doors along the means of egress with side-hinged, swinging egress doors. If locks are required for security reasons, utilize special door locking features complying with NFPA 101.	Immediate	On 16/03/2016: Corrected. (Factory has removed all collapsible gates/ sliding doors and installed sewing type door). On 04/09/2016: Corrected as per site observation. On 23.11.2016: Corrected On 7th February 2017 As action plan of the factory: Corrected as per previous follow-up inspection. On 30/04/2017: Corrected On 10.08.2017: Corrected as per site observation. On 02/02/2018: Corrected. On 01/08/2018: Corrected.	'16/03/2016	Done	Corrected

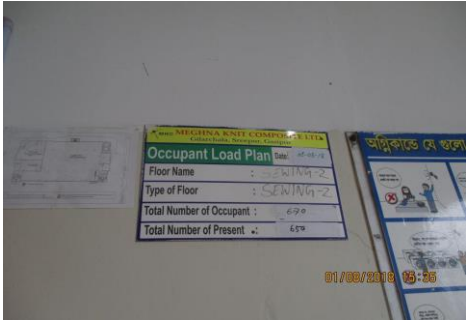
10	Exit capacity of 706 persons is not adequate for the occupant load of Levels 3 (742 people) and 4 (746 people).	The building owner should reduce occupant load to not more than 706 persons per floor or provide additional exits.	Within 3 months	On 04/09/2016: Not corrected. No action has been taken yet. On 23.11.2016: Corrected. Factory has increased exit door width and reduced some occupants from the floors. On 7th February 2017 As action plan of the factory: Corrected as per previous follow-up inspection. On 30/04/2017: Corrected On 10.08.2017: Corrected as per last follow-up inspection. On 02/02/2018: Corrected. On 01/08/2018: Corrected.	'30/09/2016	We've reduce the floors manpower also we've installed 02 large size Fire doors (06 feet doors) in 02 sewing floors to smooth the easy exit of the employees of the floors	Corrected

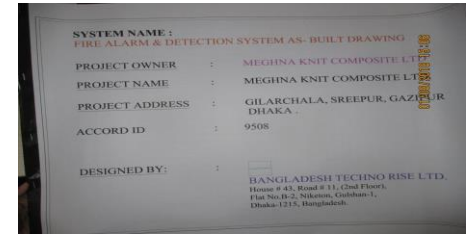
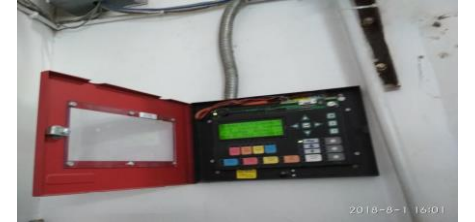
13 The fire alarm system is antiquated, not a listed system, and does not provide alarm and notification features consistent with acceptable standards.

On 7th February 2017 As action plan of the factory: Partially corrected. Reviewed drawing from Accord was available during 6th follow-up inspection. Installation was almost completed. Fire doors, HVAC system, fire pump controls should be interfaced with FACP if applicable. Factory have to prove whether the installed fire alarm cable & fire alarm product has been certified by any third party. (Commissioning of the system in front of contractor/ 3rd party will be done by Accord)
 On 30/04/2017: In progress. T&Cx required.
 On 10.08.2017: In progress. Testing & commissioning is required.
 On 02/02/2018: Completed. T&C is pending.
 On 01/08/2018: Installation is completed. Awaiting for T&C.

Replace the fire alarm system with a new, listed addressable fire alarm system in accordance with NFPA 72.

We have installed the listed addressable fire alarm system as per the NFPA 72.

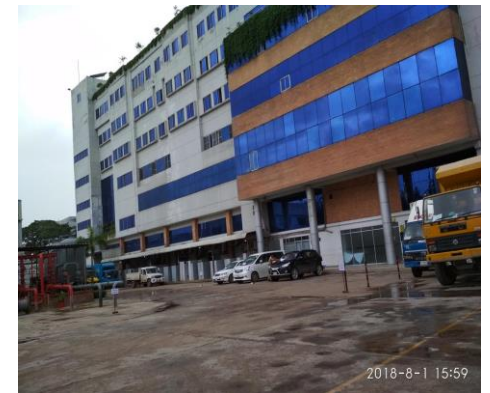
14 The high-rise building has an occupied floor greater than 23m (75 ft) and is not provided with automatic sprinkler protection. The large occupant loads, heavy fuel loading, and anticipated extended egress

On 16/03/2016: Corrected. (Not applicable as highest occupied floor is less than 23 meter).
 On 04/09/2016: Corrected as per site observation.
 On 23.11.2016: Corrected as per site observation.
 On 7th February 2017 As action plan of the factory: Corrected as per previous follow-up inspection.
 On 30/04/2017: Corrected
 On 10.08.2017: Corrected as per site observation.
 On 02/02/2018: Corrected as per site observation.
 On 01/08/2018: Corrected.

Provide automatic sprinkler protection throughout the building in accordance with NFPA 13.

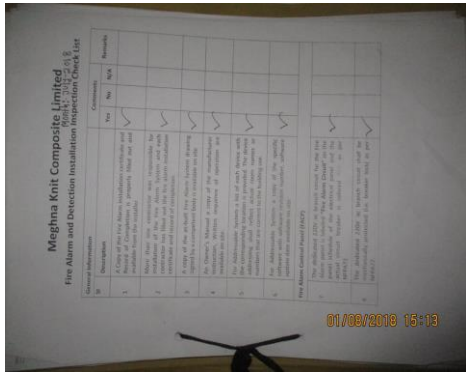
15 Testing and maintenance records for the fire alarm system were not available.

On 16/03/2016: In progress. It is an integrated part of fire alarm system.
 On 04/09/2016: It is an integrated part of fire alarm system.
 On 23.11.2016: It is an integrated part addressable fire alarm system.
 On 7th February 2017 As action plan of the factory: Corrected.
 On 30/04/2017: Corrected
 On 10.08.2017: Corrected.
 On 02/02/2018: Corrected.

Inspect, test and maintain the fire alarm system, and keep written records on-site, in accordance with NFPA 72.

Accord has reviewed the Fire Detection system's drawing and design on 15/03/2016. Based on review we're in process to install and modify the fire alarm system and we'll maintain the testing & maintenance record accordingly.

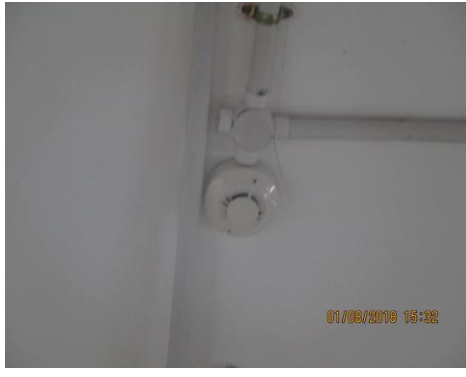
16 The building is equipped with single-station smoke alarms. Smoke alarm activation sounds only a local alarm and does not provide automatic fire alarm notification of occupants.

On 16/03/2016: In progress. It is an integrated part of fire alarm system.
 On 04/09/2016: It is an integrated part of fire alarm system.
 On 23.11.2016: It is an integrated part of addressable fire alarm system.
 On 7th February 2017 As action plan of the factory: Corrected. Factory has installed the addressable fire alarm system.
 On 30/04/2017: Corrected
 On 10.08.2017: Corrected as per previous follow-up inspection.
 On 02/02/2018: Corrected as per previous follow-up inspection.

Replace the single-station smoke alarms with automatic smoke detectors tied into the fire alarm system. Configure the fire alarm system to initiate occupant notification upon activation of any two smoke detectors in addition to the manual fire alarm stations.

Accord has reviewed the Fire Detection system's drawing and design on 15/03/2016. Based on review we're in process to install and modify the the fire alarm system.

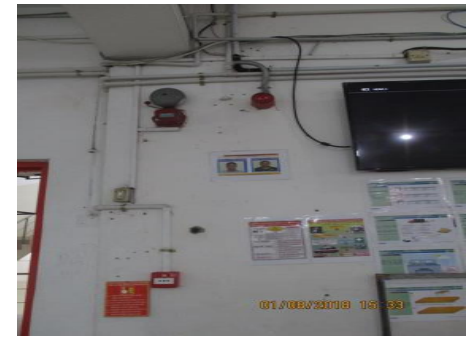
17 The fire alarm system does not appear to provide adequate audible notification coverage based upon functional test performed on Levels 2 and 3.

On 16/03/2016: In progress. It is an integrated part of fire alarm system.
 On 04/09/2016: It is an integrated part of fire alarm system.
 On 23.11.2016: It is an integrated part of addressable fire alarm system.
 On 7th February 2017 As action plan of the factory: Corrected.
 On 30/04/2017: Corrected
 On 10.08.2017: Corrected as per previous follow-up inspection.
 On 02/02/2018: Corrected as per previous follow-up inspection.

Provide additional notification appliances such that the fire alarm system is audible throughout the building in accordance with NFPA 72.

Accord has reviewed the Fire Detection system's drawing and design on 15/03/2016. Based on review we're in process to install and modify the the adequate audible notification coverage

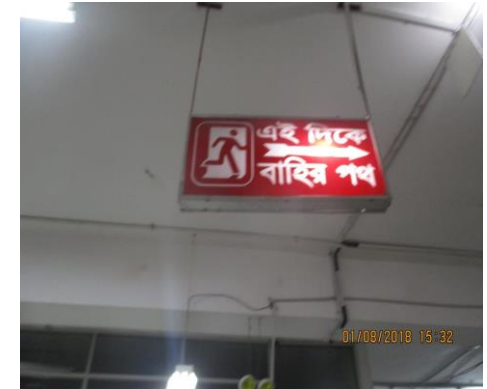
18 Directional exit signs on all levels typically point only to the northwest stairwell. Provide directional exit signage to direct occupants to the closest available exit. Within 3 months

On 16/03/2016: No action has been taken yet. It has found same as it was before.
Final CAP Timeline: Expired.
Committed Timeline: Within 30th March 2016.
On 04/09/2016: Corrected as per site observation.
On 23.11.2016: Corrected
On 7th February 2017 As action plan of the factory: Corrected as per previous follow-up inspection.
On 30/04/2017: Corrected
On 10.08.2017: Corrected as per site observation.
On 02/02/2018: Corrected.

We've installed sufficient directional exit signage to direct occupants to the closet available exit

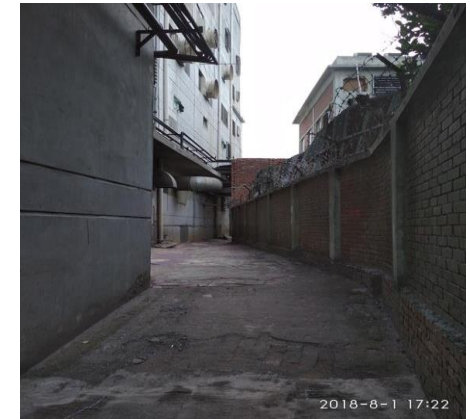
19 Fire Rated Construction: The exit discharge path serving one exit is less than 10feet wide and is not separated from the building interior. Seal all penetrations and openings interior of the building along the discharge path up to a height of 10 feet, to provide a minimum 1- hr fire rated separation and close the exit passageway in between the main building & ETP area. Within 3 months

On 16/03/2016: No action has been taken yet. It has found same as it was before.
Final CAP Timeline: Expired.
Committed Timeline: Within 31th March 2016.
On 04/09/2016: No action has been taken yet.
On 23.11.2016: In progress. Separation work is going on.
On 7th February 2017 As action plan of the factory: It has found same as it was before follow-up inspection.
On 30/04/2017: In progress.
On 10.08.2017: Corrected as per site observation.
Proper separation has been provided by fire rated construction.
On 02/02/2018: Corrected.

We're in process to enlarge the exit discharge path more than 10feet

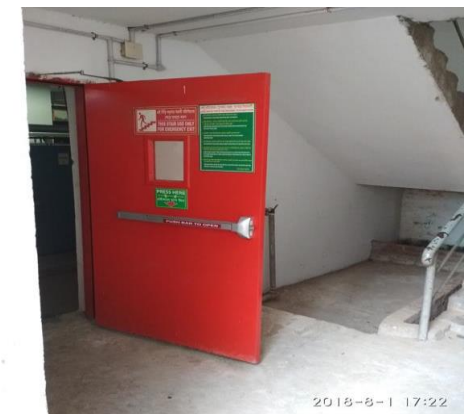
20 Egress: The third rear exit discharge path discharges directly inside the building. Modify the discharge path. Immediate

On 16/03/2016: No action has been taken yet. It has found same as it was before.
Final CAP Timeline: Expired.
Committed Timeline: Within 30th April 2016.
On 04/09/2016: Corrected as per site observation.
It is a stair coming from mezzanine floor storage room to ground floor shed.
On 23.11.2016: Corrected
On 7th February 2017 As action plan of the factory: Corrected as per previous follow-up inspection.
On 30/04/2017: Corrected
On 10.08.2017: Corrected as per site observation.
On 02/02/2018: Corrected.

We're on process to modify the egress path

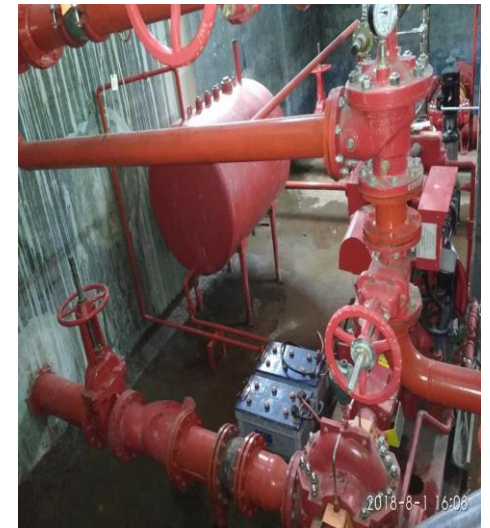
22	<p>New Finding: The existing standpipe system of the building is not as per any reviewed design and not in accordance with NFPA 14 for the highest occupied floor is greater than 3m or 10 ft.</p>	<p>Design & install a class III standpipe system for the building. Submit the design to Accord for review before installation.</p>	Design within 2 months, install within 6 months.	<p>On 16/03/2016: No action has been taken yet. It has found same as it was before. Final CAP Timeline: Expired. Committed Timeline: Within 30th April 2016. Factory asked 30/09/2016 which is not accepted. Final time line expired. On 04/09/2016: Initial submitted drawing has been rejected by Accord. Re-submission of drawing has not been done yet. On 23.11.2016: In progress. Design has been reviewed from Accord and modification work is almost completed. On 7th February 2017 As action plan of the factory: It has found same as it was before follow-up inspection. On 30/04/2017: In progress. On 10.08.2017: In progress. LC for fire pump has been opened and other installation work is going on. On 02/02/2018: Fire pump installation is going on.</p> <p>On 01/08/2018: Reviewed drawing was found available on site. Fire pump is already installed with positive suction. Awaiting for T&C.</p>	'15/07/2018	The design already reviewed by the ACCORD and the installation of stand pipe is almost 95 % completed in accordance with NFPA 72.	In Progress

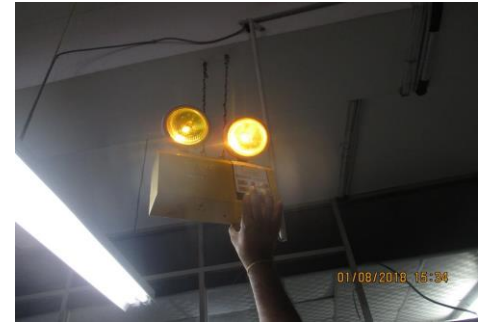
23 New Finding- (3rd Follow-up): Manual on-off switch is provided for [emergency lighting / exit signage] units.
Remove manual on/off switches from emergency lighting / exit signage units to prevent them from being switched off.
Within 1 Month
New Finding
On 04/09/2016: Corrected as per site observation.
On 23.11.2016: Corrected
On 7th February 2017 As action plan of the factory: Corrected as per previous follow-up inspection.
On 30/04/2017: Corrected
On 10.08.2017: Corrected as per site observation.
On 02/02/2018: Corrected as per site observation.
On 01/08/2018: Corrected.

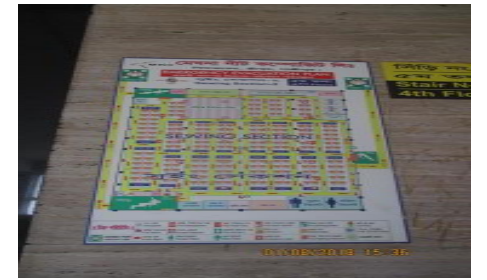
24 New Finding (4th Follow-up): Fire evacuation maps is not posted at the entrance of South exit stair at all level.
Fire evacuation maps shall be posted at the entrance to each exit stair.
Immediate
On 04/09/2016: New Finding
On 23.11.2016: Corrected
On 7th February 2017 As action plan of the factory: Corrected as per previous follow-up inspection.
On 30/04/2017: Corrected
On 10.08.2017: Corrected as per site observation.
On 02/02/2018: Corrected as per site observation.
On 01/08/2018: Corrected.

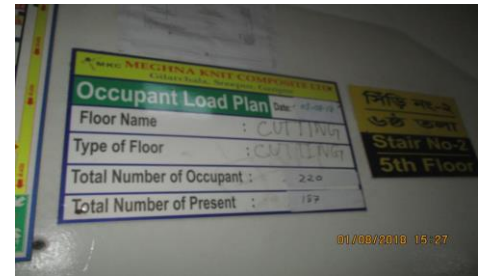
25 New Finding (4th Follow-up): Occupant load sign and stair designation is not posted at the exit stair at all level.
Occupant load sign and stair designation shall be posted at the entrance to exit stair at all level.
Immediate
On 04/09/2016: New Finding
On 23.11.2016: Corrected
On 7th February 2017 As action plan of the factory: Corrected as per previous follow-up inspection.
On 30/04/2017: Corrected
On 10.08.2017: Corrected as per site observation.
On 02/02/2018: Corrected as per site observation.
On 01/08/2018: Corrected.

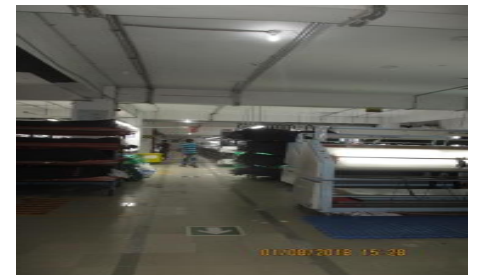
26 New Finding (4th Follow-up): Width of aisles is less than 0.9m (36-in.).
Aisles shall be provided with a minimum unobstructed clear-width of 0.9 m (36 in.).
Immediate
On 04/09/2016: New Finding
On 23.11.2016: Corrected
On 7th February 2017 As action plan of the factory: Corrected as per previous follow-up inspection.
On 30/04/2017: Corrected
On 10.08.2017: Corrected as per site observation.
On 02/02/2018: Corrected as per site observation.
On 01/08/2018: Corrected.

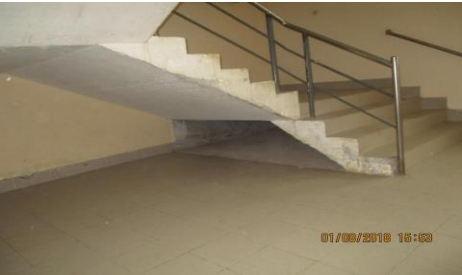
28	New Finding (4th Follow-up): Storage was located in the exit stair. (Finished goods, Electrical panel e.t.c)	Remove all storage from exit stairs.	Immediate	On 04/09/2016: New Finding On 23.11.2016: Corrected On 7th February 2017 As action plan of the factory: Corrected as per previous follow-up inspection. On 30/04/2017: Corrected On 10.08.2017: Corrected as per site observation. On 02/02/2018: Corrected as per site observation. On 01/08/2018: Corrected.	'20/09/2016	We've removed all storage areas from the exit stairs and egress paths	Corrected

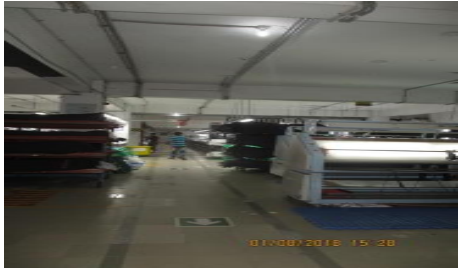
29	New Finding (4th Follow-up): Emergency lights not illuminated during testing (burned out, broken, etc.).	Regularly inspect all emergency lighting system as per Accord standard and replace/install lights as needed to illuminate signs.	Immediate	On 04/09/2016: New Finding On 23.11.2016: Corrected On 7th February 2017 As action plan of the factory: Corrected as per previous follow-up inspection. On 30/04/2017: Corrected On 10.08.2017: Corrected as per site observation. On 02/02/2018: Corrected as per site observation. On 01/08/2018: Corrected.	'20/09/2016	Emergency lights are now illuminated in all areas	Corrected

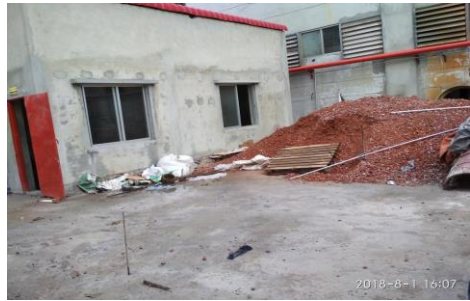
30	New Finding (4th Follow-up): Fire pump room is not separated from adjacent occupancies by fire rated assemblies.	Provide a minimum 2-hr fire rated assemblies to separate it from production area. Seal and/or protect all openings to maintain fire separations.	Within 1 month	On 04/09/2016: New Finding On 23.11.2016: It was found same as 4th follow-up inspection during 5th follow-up inspection. On 7th February 2017 As action plan of the factory: It has found same as it was before follow-up inspection. On 30/04/2017: In progress. On 10.08.2017: LC has been opened for fire pump. On 02/02/2018: Installation is going On 01/08/2018: Installation is already done and fire pump room was found separated from other occupancies.	'31/12/2016	We have separated the fire pump room from the production area which is fully fire rated assemblies.	Corrected
