FIRE SAFETY FOLLOW UP INSPECTION

Factory Name	Executive Intimates Ltd		Accord ID	23101
Address	Dhaka-Mymensingh Road,Gargoriai Masterbari, Aspara mor, Gilarchala, Sreepur, Gazipur			
Initial Inspection Date	25-Feb-2018		Report Received Date	
Date of 1st Follow-up	06-Sep-2018	Date of 2nd Follow-up	06-Feb-2019	
Date of 3rd Follow-up	11/09/2019	Date of 4th Follow-up		
Date of 5th Follow-up		Date of 6th Follow-up		
Date of 7th Follow-up		Date of 8th Follow-up		
Date of 9th Follow-up		Date of 10th Follow-up		
Date of 11th Follow-up		Date of 12th Follow-up		
Date of 13th Follow-up		Date of 14th Follow-up		
Inspected by	Tarif Raihan

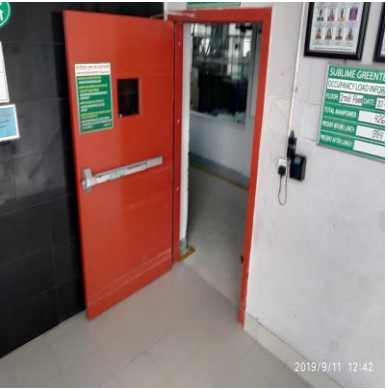
Item No	Accord Observation	Accord Recommendation	Timeline given by Accord	Comments after Physical Inspection	Supposed to complete(DD/MM/YYYY)	Final Action Plan (Factory)	Status on the date of Inspection	Pictorial Evidence
1	The exit stairs are not separated from [work areas, other spaces] on each floor by fire-rated construction.Location: Building 1 & Building 2.	Stair shall be enclosed with a minimum 2-hr fire rated construction. Seal all unprotected openings and provide minimum 2-hr fire rated doors to separate the exit stairs from work areas and other building spaces on all floor levels. Ensure that the fire doors are self-closing, positive latching and that they are provided with fire exit (panic) hardware where serving production floors.If fire doors are required to be held open for functional reasons, provide automatic-closing devices tied to the fire alarm system.Note: The gap between floor level and fire door was not found as per standard, door co-coordinator & door closure was found missing during inspection. Also, fire door was found held open by external forces.	Within 3 months	On 06/09/2018: Partially corrected. Civil related construction work & fire rated doors were found completed. Interfacing with FACP was observed improper. Fire doors were found not functional due to door coordinators is not working properly during inspection. On 06/02/2019: Corrected. On 11/09/2019: Corrected.	10-Jun-2018	The exit stairs is separated form all work areas on each floor and sealed all unprotected openings. Done by: 30 November 18 Accord Pending Verification	Corrected

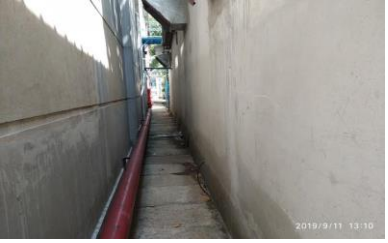
2	The exit discharge path serving west exit stair is less than 10 ft. wide and is not separated from the transformer.Location: building 2.	Seal all penetrations and openings to the interior of the building along the discharge path, up to a height of 10 ft. to provide a minimum 1-hr fire separation. Alternatively, provide a second remote discharge path to the public way (only include this if feasible).	Within 3 months	On 06/09/2018: Corrected. On 06/02/2019: Corrected as per previous follow up. On 11/09/2019: Corrected as per previous follow up.	10-Jun-2018	Completed	Corrected

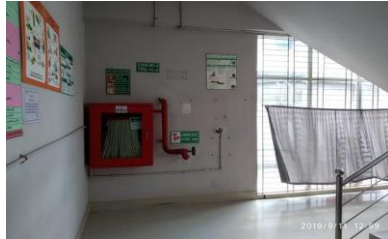
Item No	Accord Observation	Accord Recommendation	Timeline given by Accord	Comments after Physical Inspection	Supposed to complete(DD/MM/YYYY)	Final Action Plan (Factory)	Status on the date of Inspection	Pictorial Evidence
3	The exit stairs discharge inside the building to the ground floor. Location: Building 1.	Modify the stairs to dischargedirectly outside.Alternately, provide 2-hr fire ratedexit passagewayleading directly outside(vestibules to separate anystorage areas).	Within 6 months	On 06/09/2018: Partially corrected. Civil related construction work & fire rated doors were found completed. Interfacing with FACP was observed improper. Fire doors were found not functional due to door coordinators is not working properly during inspection. On 06/02/2019: Progress done but yet not finished. On 11/09/2019: Corrected. All fire doors are working properly. SDB board on stair case has been removed.	10-Sep-2018	Already modified the stair discharge and removed all hazardous elements Present Status: Done Pending Verification	Corrected

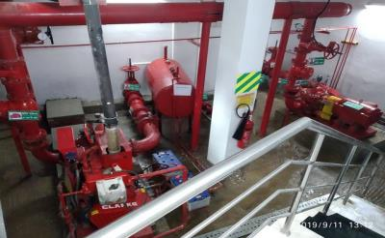
Item No	Accord Observation	Accord Recommendation	Timeline given by Accord	Comments after Physical Inspection	Supposed to complete(DD/MM/YYYY)	Final Action Plan (Factory)	Status on the date of Inspection	Pictorial Evidence
15	The existing factory building with an Occupiable floor greater than 10 m (33 ft.) above the finished grade is not protected with an approved standpipe system. Location: Building 1.	Submit As-Built drawing to AHJ for approval and replace or modify the standpipe system in accordance with NFPA 14.	Within 2 months (Design submission) & 9 months (Installation)	On 06/09/2018: In progress. Design reviewed from ACCORD on 19 Aug 2018. Installation and modification work is on going. On 06/02/2019: Awaiting for Testing and commissioning. On 11/09/2019: Waiting for T&C.	17-Feb-2019	Standpipe installation has completed. We need testing & commissioning. Status: Pending Verification	In Progress

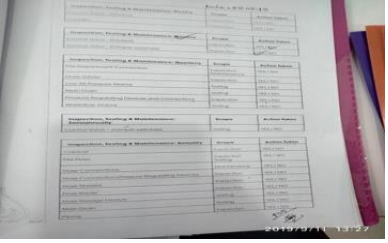
16	Inspection, testing, and maintenance of the standpipe system is not in accordance with NFPA 14 or as per Accord standard. Location: Building 1.	Inspect, test and maintain the standpipe system and keep written records on-site, in accordance with NFPA 14 or as per Accord standard.	Within 3 months	On 06/09/2018: It is an integrated part of fire fighting system. On 06/02/2019: Corrected On 11/09/2019: Corrected.	15-Jun-2018	As-built drawing is submitted on 22 July.18. Execution work is completed. Accord Pending Verification	Corrected

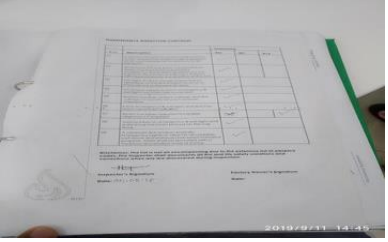
17	Inspection, testing, and maintenance for the portable fire extinguisher is not in accordance with NFPA 10 or as per Accord standard. Location: Building 1, Building 2, Building 3 & Shed.	Inspect, test and maintain the portable fire extinguisher and keep written records on-site in accordance with NFPA 10 or as per Accord standard.	Within 1 month	On 06/09/2018: Corrected. On 06/02/2019: Corrected. On 11/09/2019: Corrected.	18-Apr-2018	Completed	Corrected
