FIRE SAFETY FOLLOW UP INSPECTION

Factory Name	Sublime Greentex Limited		Accord ID	23102
Address	Dhaka-Mymensingh road, Gargoriai Masterbari, Aspara Mor Gilarchala, Sreepur, Gazipur			
Initial Inspection Date	25-Feb-2018	Report Received Date		
Date of 1st Follow-up	06-Feb-2019	Date of 2nd Follow-up	11/09/2019	
Date of 3rd Follow-up		Date of 4th Follow-up		
Date of 5th Follow-up		Date of 6th Follow-up		
Date of 7th Follow-up		Date of 8th Follow-up		
Date of 9th Follow-up		Date of 10th Follow-up		
Date of 11th Follow-up		Date of 12th Follow-up		
Date of 13th Follow-up		Date of 14th Follow-up		
Inspected by	Tarif Raihan

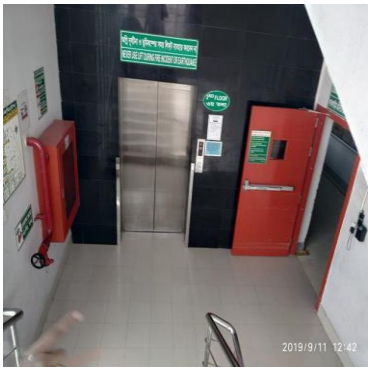
Item No	Accord Observation	Accord Recommendation	Timeline given by Accord	Comments after Physical Inspection	Supposed to complete(DD/MM/YYYY)	Final Action Plan (Factory)	Status on the date of Inspection	Pictorial Evidence
1	The exit stairs are not separated from [work areas, other spaces] on each floor by fire-rated construction. Location: Building 1 & Building 2.	Stair shall be enclosed with a minimum 2-hr fire-rated construction. Seal all unprotected openings and provide minimum 2-hr fire rated doors to separate the exit stairs from work areas and other building spaces on all floor levels. Ensure that the fire doors are self-closing, positive latching and that they are provided with fire exit (panic) hardware where serving production floors. If fire doors are required to be held open for functional reasons, provide automatic-closing devices tied to the fire alarm system. Note: The gap between floor level and fire door was not found as per standard. door co-coordinator & door closure was found missing during inspection. Also, fire door was found held open by external forces.	Within 3 months	On 06/02/2019: Corrected. On 11/09/2019: Corrected.	10-Jun-2018	The exit stairs is separated form all work areas on each floor and sealed all unprotected openings. Done by: 30 November 18 Accord Pending Verification	Corrected

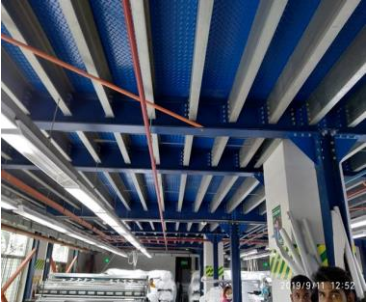
7	1st floor of Building-1 has 3 parts. One part (Middle Part of the floor) is Pre-fabricated steel (Part-1) which is non-rated structure and another 2 parts is RCC frame (Part-2 & 3). Part-1, Part 2 and Part-3 are not physically separate buildings but have a structurally independent fire wall separating them. From visual inspection all those structural members were found free of damage during assessment. Since the structure is steel-composite type and all the RCC panels are resting on the steel beams and slab. Hench, ground & 1st floor of the building is not separated by a fire resistive rated protection construction barriers	Provide fire-resistive rated construction barriers between floors following Section 4.4 and Table 4.4.1 of the Accord Standard or Table 3.3.1 and Table 4.1.1 from BNBC Part 4. Consult a qualified fire protection engineer to design the rated construction barriers.	Within 6 months	On 06/02/2019: Factory collected quotation on fire resistive construction. Yet construction work not started.Shall be done within 06/04/2019 On 11/09/2019: In progress.	06-Apr-2019	Will be separated by fire resistive rated Protection as per instruction. Done by: 31 March 2019 In-Progress	In Progress
