FIRE SAFETY FOLLOW UP INSPECTION

Factory Name	MEGHNA KNIT COMPOSITE LIMITED		Accord ID	9508
Address	SRIIPUR ROAD, GILARCHALA, SRIIPUR			
Inspection Date	08/04/2014		Report Received Date	
Date of 1st Follow-up	04/09/2014	Date of 2nd Follow-up	07/12/2015	
Date of 3rd Follow-up	16/03/2016	Date of 4th Follow-up	04/09/2016	
Date of 5th Follow-up	23/11/2016	Date of 6th Follow-up	07/02/2017	
Date of 7th Follow-up	30/04/2017	Date of 8th Follow-up	10/08/2017	
Date of 9th Follow-up	02/04/2018	Date of 10th Follow-up	01/08/2018	
Date of 11th Follow-up		Date of 12th Follow-up		
Date of 13th Follow-up		Date of 14th Follow-up		
Inspected by	Johana Sharmin

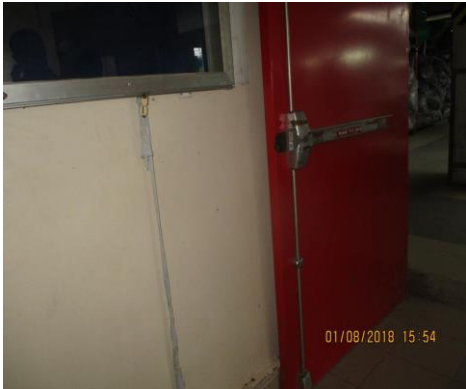
Item No	Accord Observation	Accord Recommendation	Timeline given by Accord	Comments after Physical Inspection	Supposed to complete(DD/M M/YYYY)	Final Action Plan (Factory)	Status on the date of Inspection	Pictorial Evidence
8	Egress doors / gates with locking features are provided at building exits, exit stairs, along paths of egress, and means of exit discharge. Most gates/doors within the factory were open and unlocked during the inspection.	Remove locking features from all egress doors /gates that serve the highrise.If locks are required for security reasons, utilize special door locking features complying with NFPA 101.	Immediate	On 16/03/2016: Corrected. (Factory has removed all egress doors / gates with locking features). On 04/09/2016: Corrected as per site observation. On 23.11.2016: Corrected On 7th February 2017 As action plan of the factory: Corrected as per previous follow-up inspection. On 30/04/2017: Corrected On 10.08.2017: Corrected as per site observation. On 02/02/2018: Corrected. On 01/08/2018: Corrected.	'30/09/2016	Done	Corrected

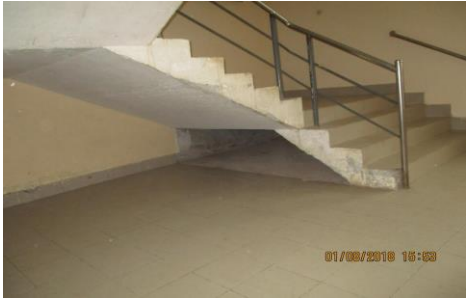
Item No	Accord Observation	Accord Recommendation	Timeline given by Accord	Comments after Physical Inspection	Supposed to complete(DD/M M/YYYY)	Final Action Plan (Factory)	Status on the date of Inspection	Pictorial Evidence
11	Storage and assorted combustibles were located in the exit stairs including trash cans, a prayer room, and garment materials.	Remove all storage from exit stairs and egress paths.	Within 3 months	<p>On 16/03/2016: Corrected. (Factory has been removed all storage from exit stairs including trash cans, a prayer room, and garment materials).</p> <p>On 7th February 2017 As action plan of the factory: Corrected as per previous follow-up inspection.</p> <p>On 30/04/2017: Corrected</p> <p>On 10.08.2017: Corrected as per site observation.</p> <p>On 02/02/2018: Corrected.</p> <p>On 01/08/2018: Corrected.</p>	'16/03/2016	We've removed all storage areas from the exit stairs and egress paths	Corrected

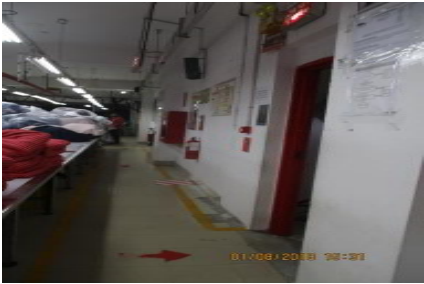
Item No	Accord Observation	Accord Recommendation	Timeline given by Accord	Comments after Physical Inspection	Supposed to complete(DD/M M/YYYY)	Final Action Plan (Factory)	Status on the date of Inspection	Pictorial Evidence
27	New Finding (4th Follow-up): The egress path along means of egress has interrupted by obstruction/storage. (It was reflected all through the production floors.)	Means of egress shall be maintained continuously free and clear of all obstructions/storage.	Immediate	On 04/09/2016: New Finding On 23.11.2016: Corrected On 7th February 2017 As action plan of the factory: Corrected as per previous follow-up inspection. On 30/04/2017: Corrected On 10.08.2017: Corrected as per site observation. On 02/02/2018: Corrected as per site observation. On 01/08/2018: Corrected.	'30/09/2016	We've removed all storage areas from the egress paths	Corrected

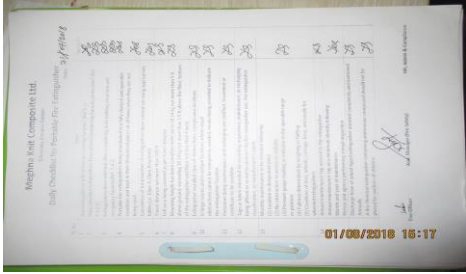
Item No	Accord Observation	Accord Recommendation	Timeline given by Accord	Comments after Physical Inspection	Supposed to complete(DD/M M/YYYY)	Final Action Plan (Factory)	Status on the date of Inspection	Pictorial Evidence
31	New Finding (4th Follow-up): Inspection, testing, and maintenance for the fire extinguishers is not in accordance with NFPA 10 or as per Accord standard.	Inspect, test and maintain the fire extinguishers, and keep written records on-site, in accordance with NFPA 10 or as per Accord standard.	Immediate	On 04/09/2016: New Finding On 23.11.2016: Corrected On 7th February 2017 As action plan of the factory: Corrected as per previous follow-up inspection. On 30/04/2017: Corrected On 10.08.2017: Corrected. On 02/02/2018: Corrected. On 01/08/2018: Corrected.	'20/09/2016	We're inspecting, testing and maintenance the Fire extinguishers as per NFPA 10	Corrected
